## PROPERTY INSPECTION REPORT # 06042007-02

**Concerning: 3256 Sample Road, Buying, Texas 70000**

**By: Mark Lyle Brown - TREC License # 9723**

**06-04-2007**

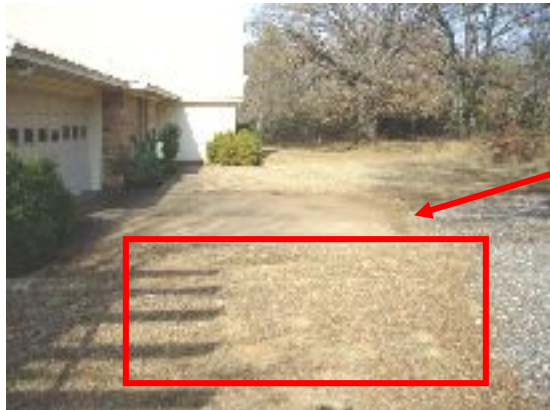
Run-off during a heave rain may try to enter the garage area. A little dirt work in the area of the box would direct the water away from the home and garage.

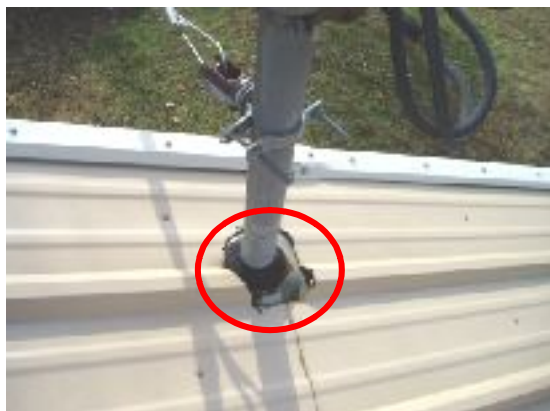
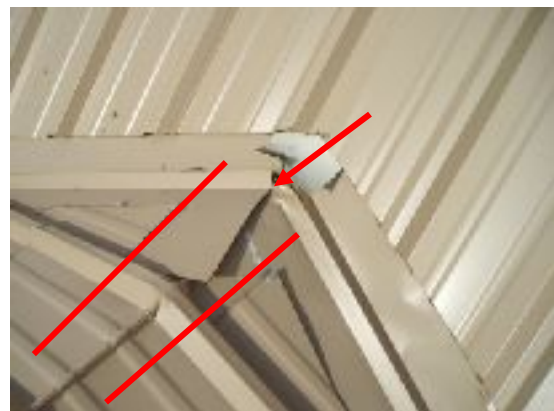
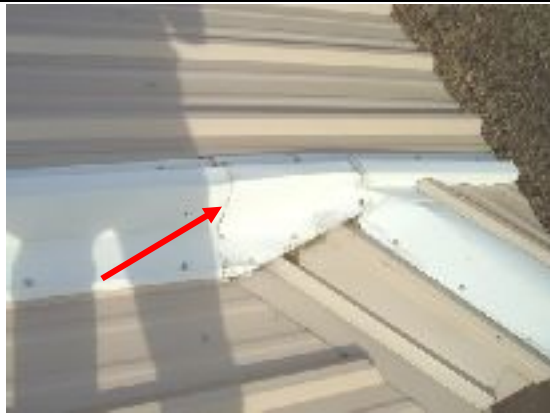
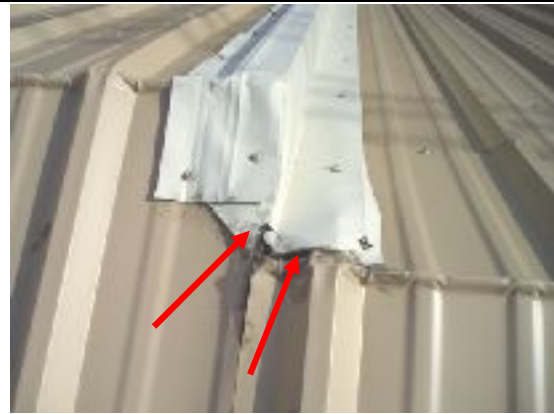
- There are several places on the roof where the sheet metal roofing is not caulked. While in most instances this is not causing water to enter the interior of the home, it is allowing water to get between the metal roof and the original shingled roof. There are water stains on the dining room ceiling (photos below in ceiling section) that have been painted over. It is undetermined when these stains occurred... before or after the metal roof was installed. However, sealing up ALL open seams on the metal roof would definitely eliminate future recurrences.

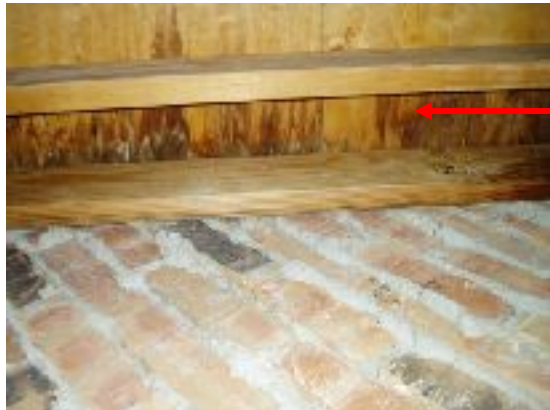
It appears that these water stains in the attic next to the chimney may have occurred prior to the metal roof installation. I did not see evidence of improper flashing and caulking around the perimeter of the chimney.

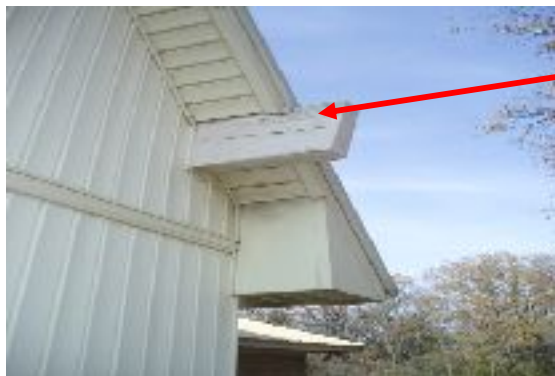
The beam is showing signs of decay. At a minimum, the beam needs sealed up good and repainted.

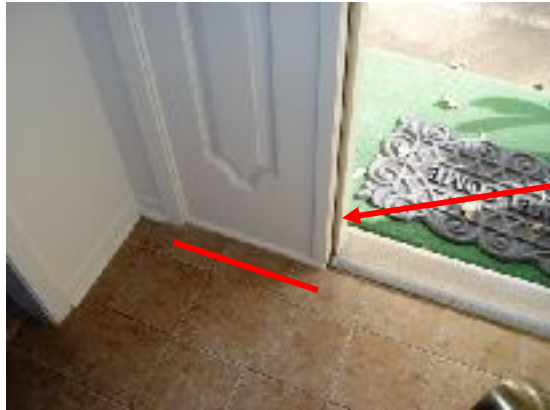
The front entrance door jam and short wall section are a little loose at the base and should be re-fastened to the slab.

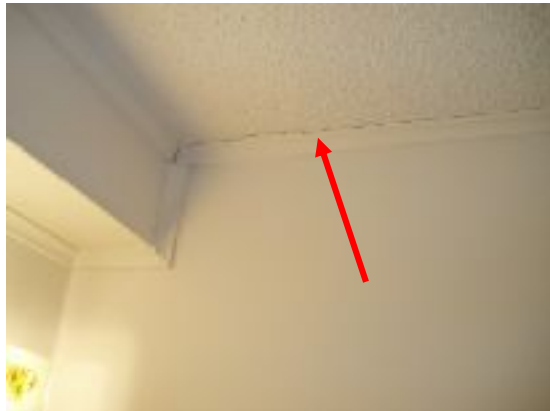
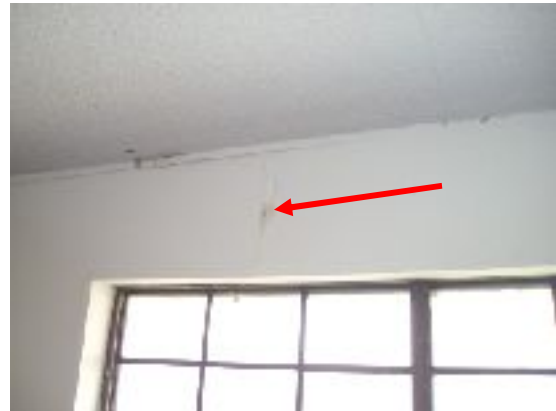
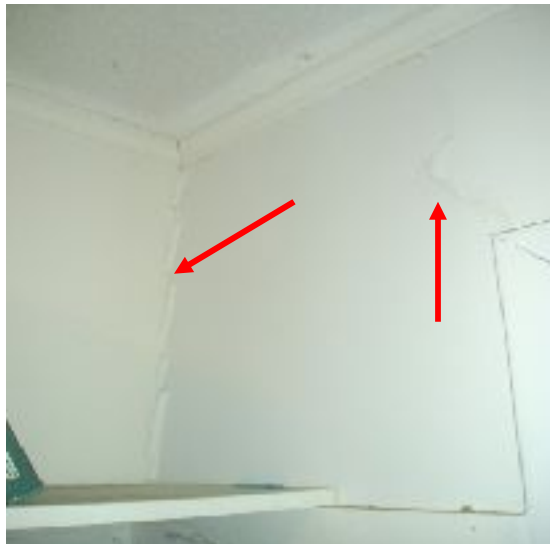
These three photos are just examples of trim separation and cracks in the sheetrock found in various places of the home. Prior to making these repairs, the notes in the foundation section above should be observed and followed to minimize future recurrences.

1. Remove the shrubbery from the perimeter of the home.
2. Keep the soil content consistent as described in 'general information' above.
3. Do not make the repairs to the interior trim and sheetrock until this is complete and the soil moisture content has a chance to stabilize.

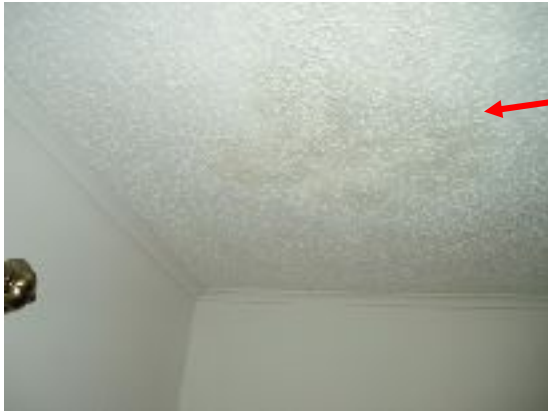
Example of water stains on the ceiling in the dining room. These spots do not appear to be recently active.

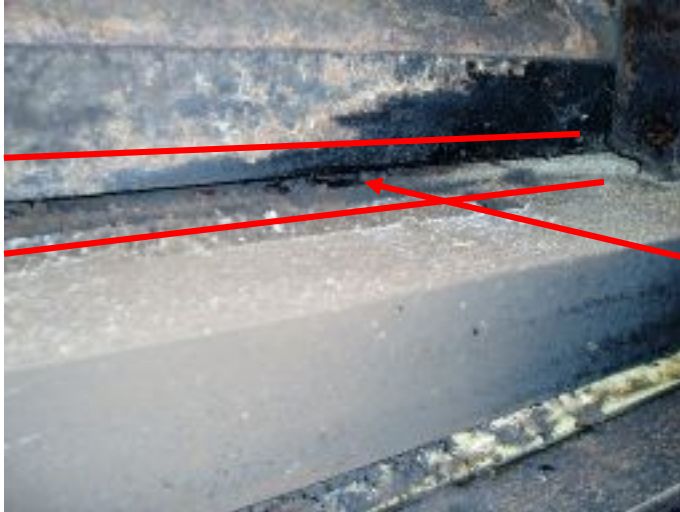
This crack between the fireplace insert and the chimney brick work needs to have mortar reapplied to ensure that all smoke and fumes exits through the damper and up the chimney.

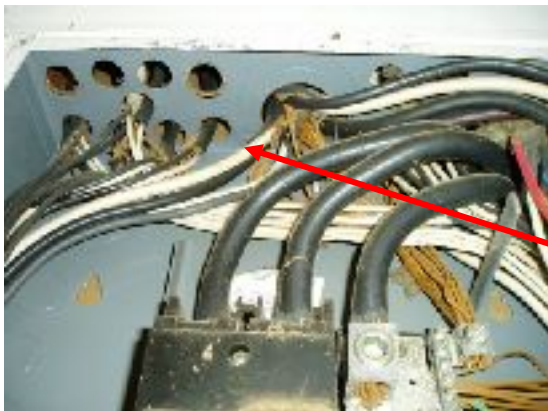
Knockout bushing installation is standard practice for wires entering & exiting metal boxes. They are not present in this box.

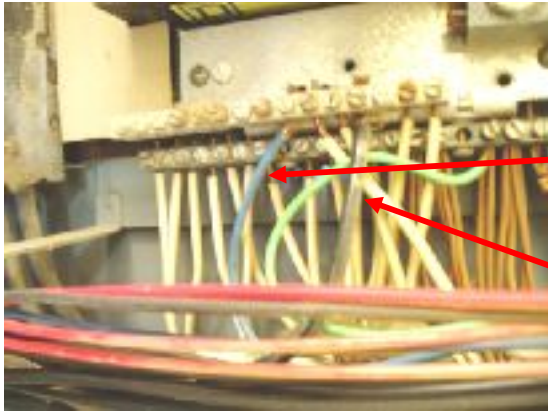
All wires on the neutral and ground buss should be green, white, or bare. All other colors should have the proper color tape applied indicating their purpose and function... an easy fix.

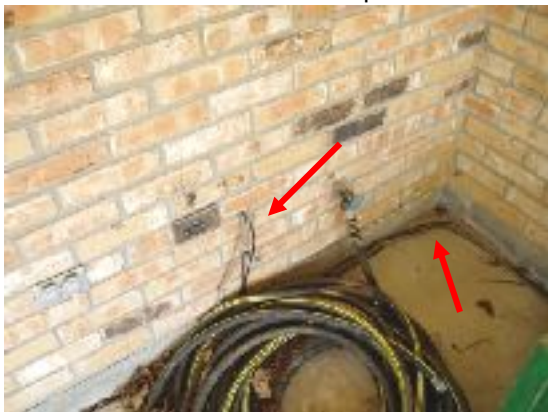
Unprotected wiring.

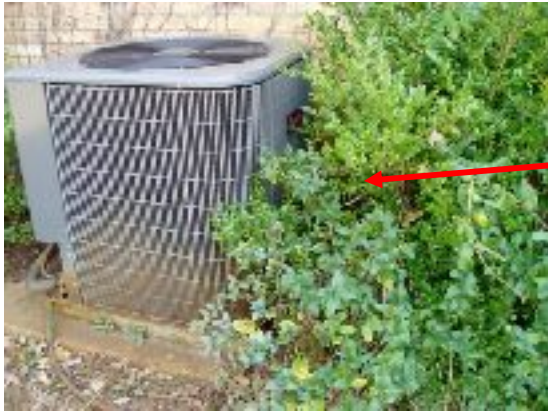
The shrubbery is against the outside Heat Pump / A/C unit. This condition prohibits proper air flow and higher utility bills. Recommend removal of the shrubbery.

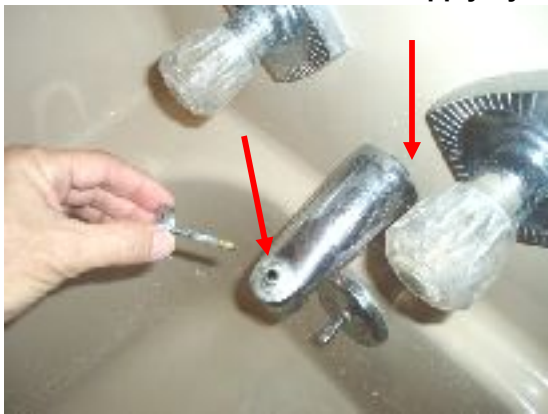
Caulk needed around tub spout. Shower pull does not work....

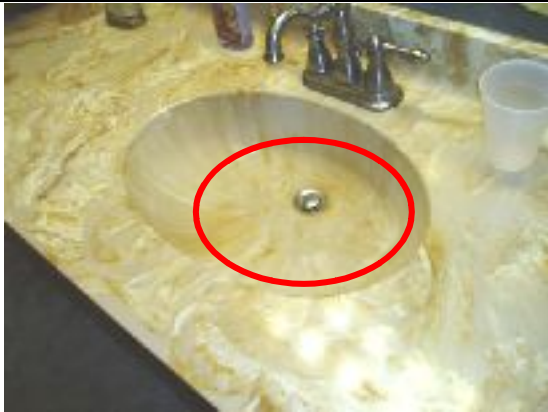
This lavatory in the master bath was very slow to drain. The stopper may simply need cleaning.

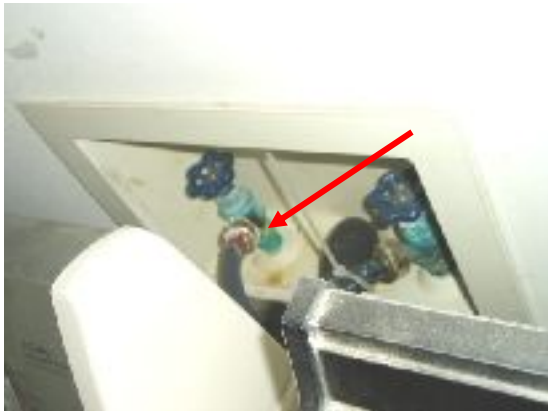
These hoses are corroded at the connection and should be replaced.

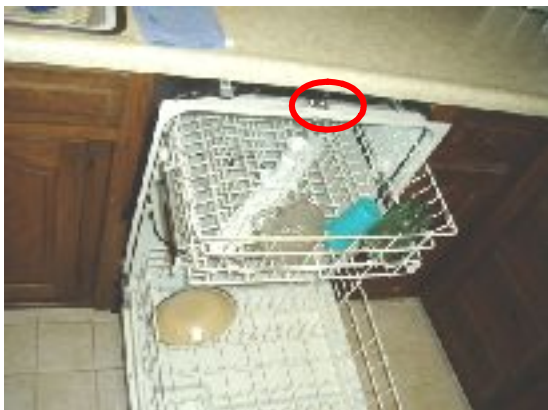
The unit's anti-tip screw is not installed allowing the unit to lean forward when the door is opened.

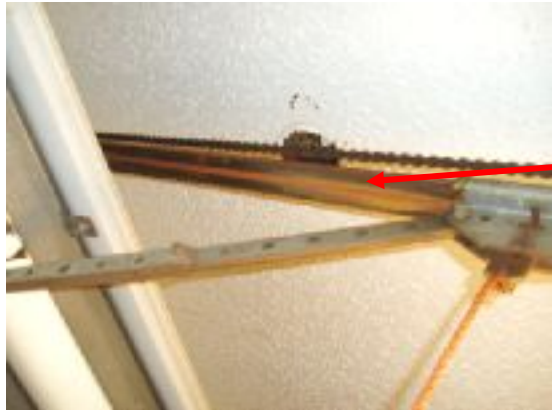
This guide slide needs lubricated to improve ease of operation of the overhead door.
